**Subject:** Caribou PH1 Unit 1 2021 Daily Status Report 7/13/2021

Caribou PH1 Unit 1 Outage 2021 Daily Status Report: July 13, 2021

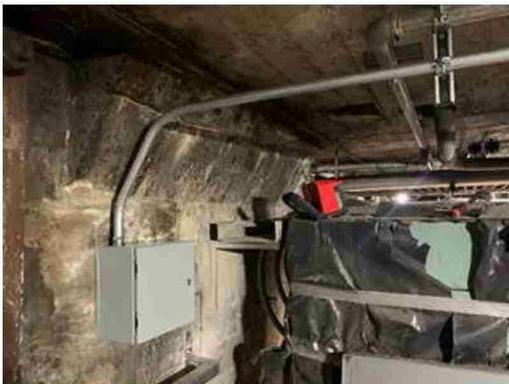
^New J-Box and Conduit in Basement

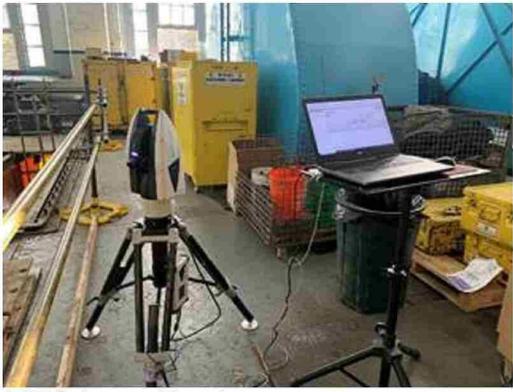
^ATIS Laser Tracker
